# INCIDENT INVESTIGATION OVERVIEW

Transocean Equinox / Moonpool Basket Pulled from Telescopic Arm

23 Jan 2026

# EQU – WORK BASKET INCIDENT INVESTIGATION

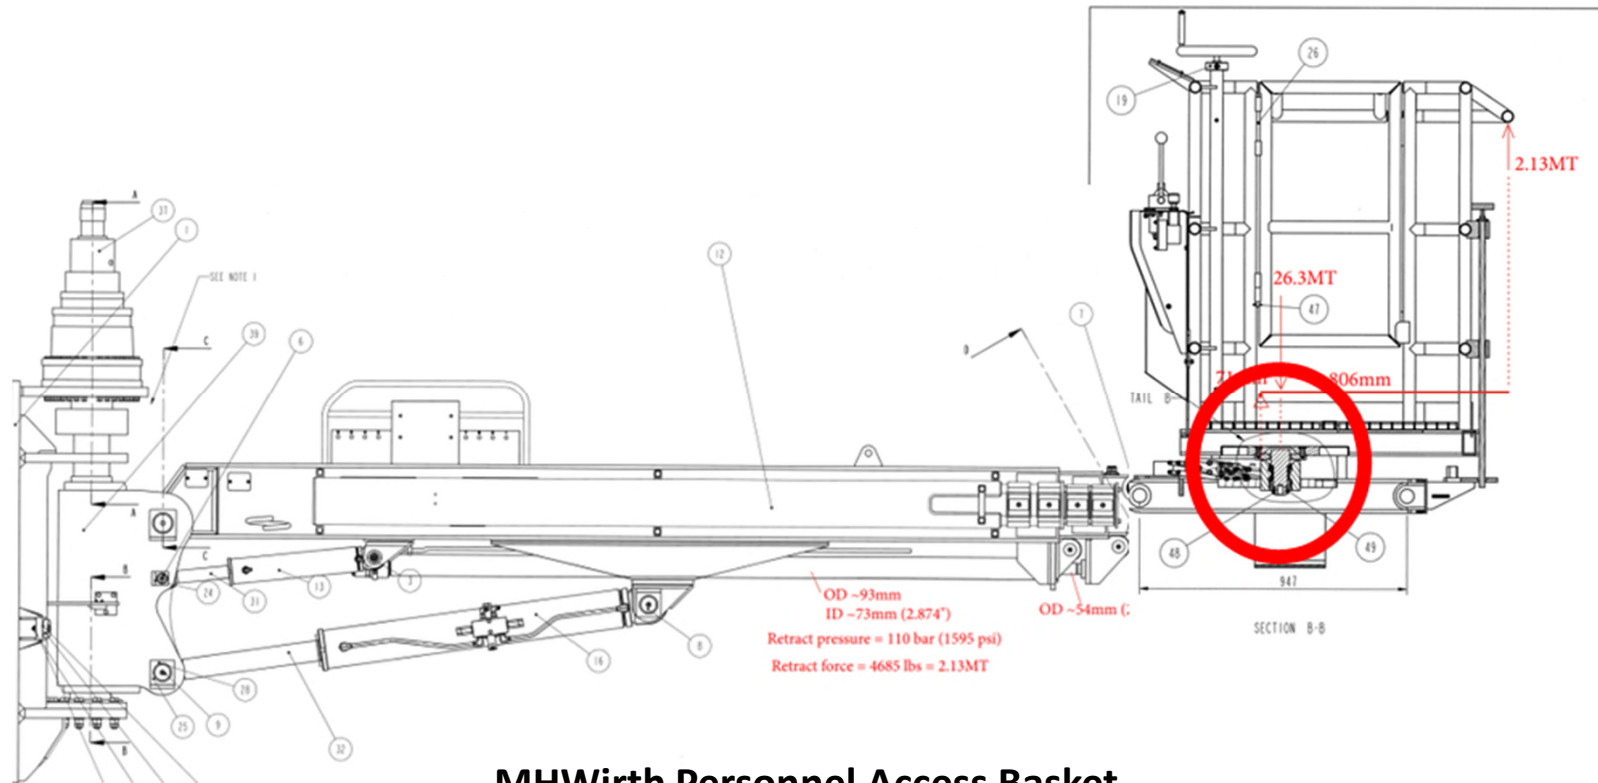
**MHWirth Personnel Access Basket**

- In-between well maintenance was ongoing.
- A work basket had been positioned below the rotary as DROPS mitigation.
- In preparation to run the diverter the work basket had to be moved clear.
- An MRT wire had been caught within the basket through the open gate.
- The operator did not see the caught wire.
- As the basket was moved, tension increased until the basket axle failed.
- The basket rotated sideways and was left suspended by the hydraulic hoses.

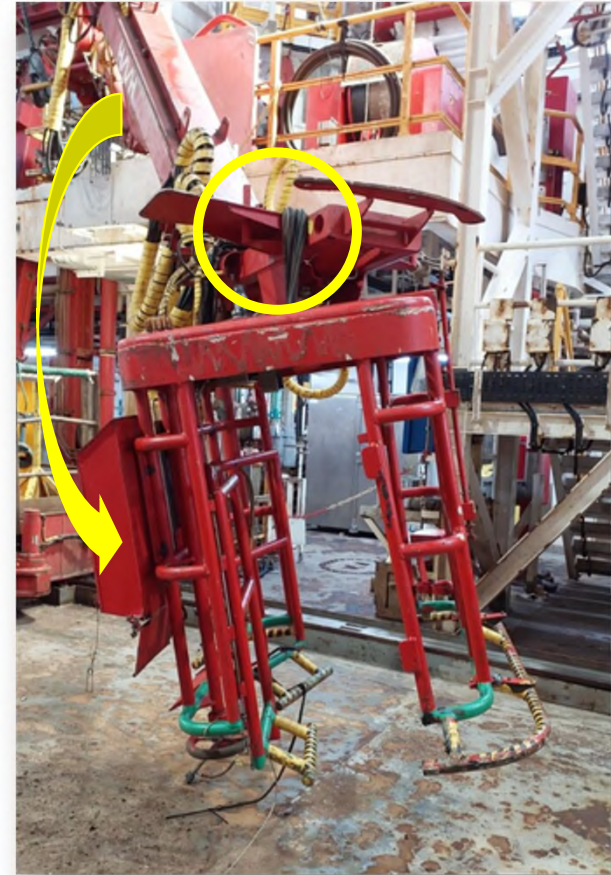
**Basket rotation axle  
vulnerable to overloading**

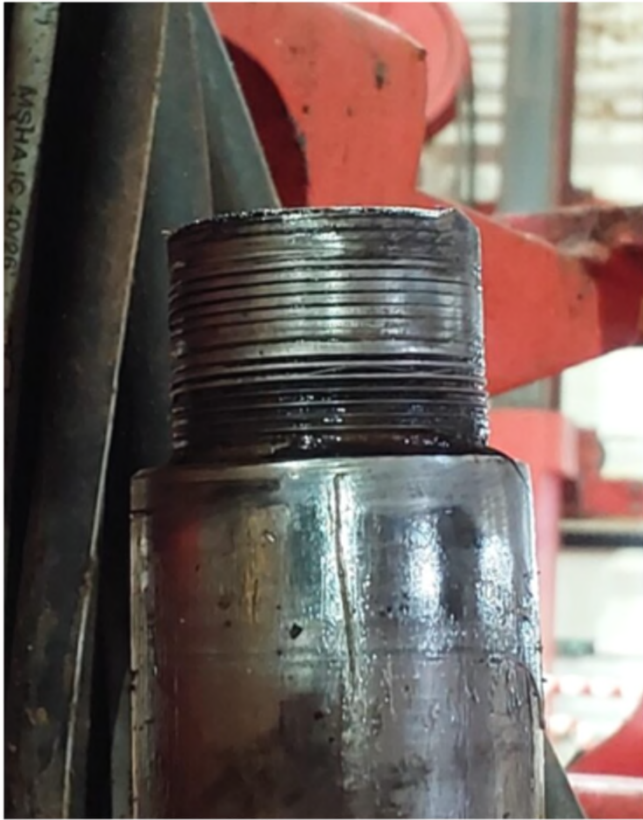
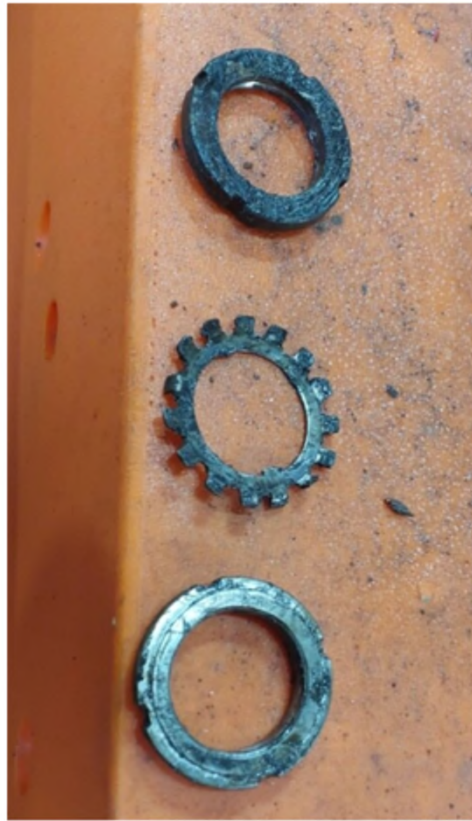
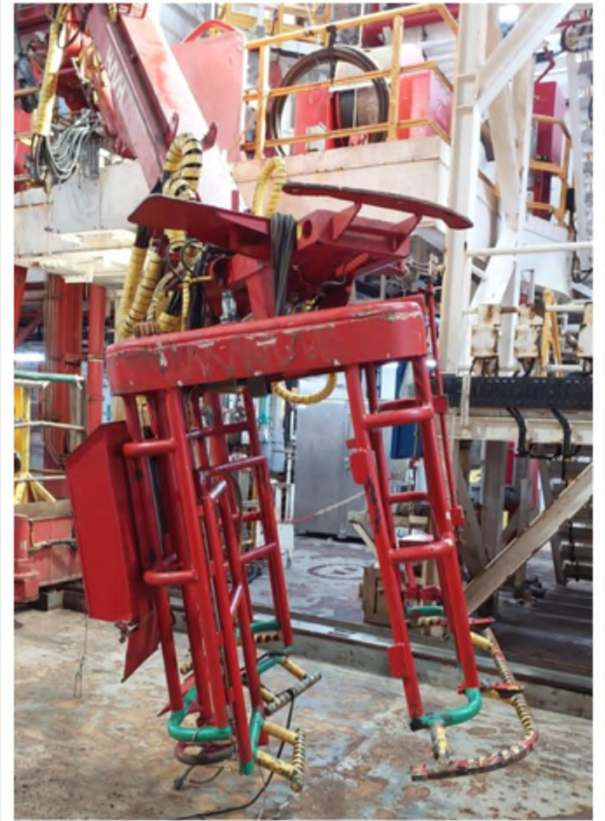
- Risk of positioning the basket close to the MRT wires was not assessed.
- Basket gate had been left open.
- Basket handrail had been modified.
- The hazard of the caught wire was not identified prior to repositioning the basket.
- Operators view was restricted.
- No spotter or banksman was assigned.
- Operator was a contract worker and not fully familiar with the operation of the basket.
- OJT did not include a demonstration or assessment of competency.
- No procedure or checklist exist for using the basket unmanned.
- Vulnerability of the basket axle design highlighted.
