# INCIDENT INVESTIGATION OVERVIEW

Transocean Equinox / Moonpool Basket Pulled from Telescopic Arm

23 Jan 2026

# EQU – WORK BASKET INCIDENT INVESTIGATION

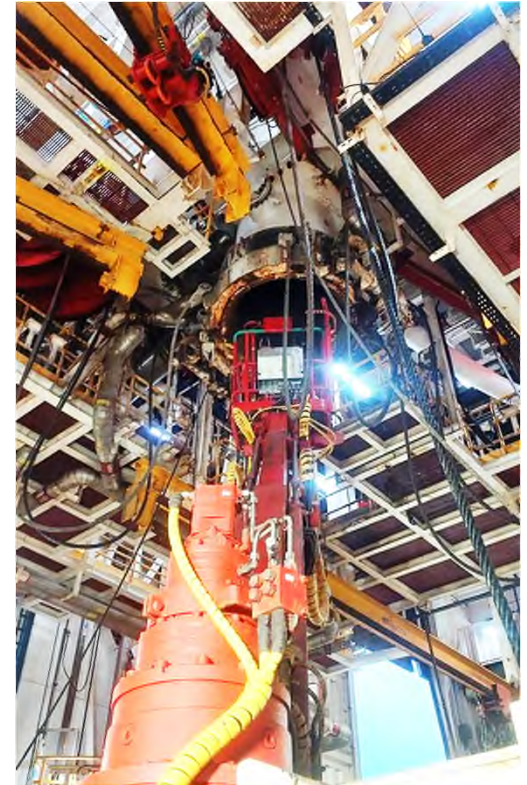
- In-between well maintenance was ongoing.
- A work basket had been positioned below the rotary as DROPS mitigation.
- In preparation to run the diverter the work basket had to be moved clear.
- An MRT wire had been caught within the basket through the open gate.
- The operator did not see the caught wire.
- As the basket was moved, tension increased until the basket axle failed.
- The basket rotated sideways and was left suspended by the hydraulic hoses.

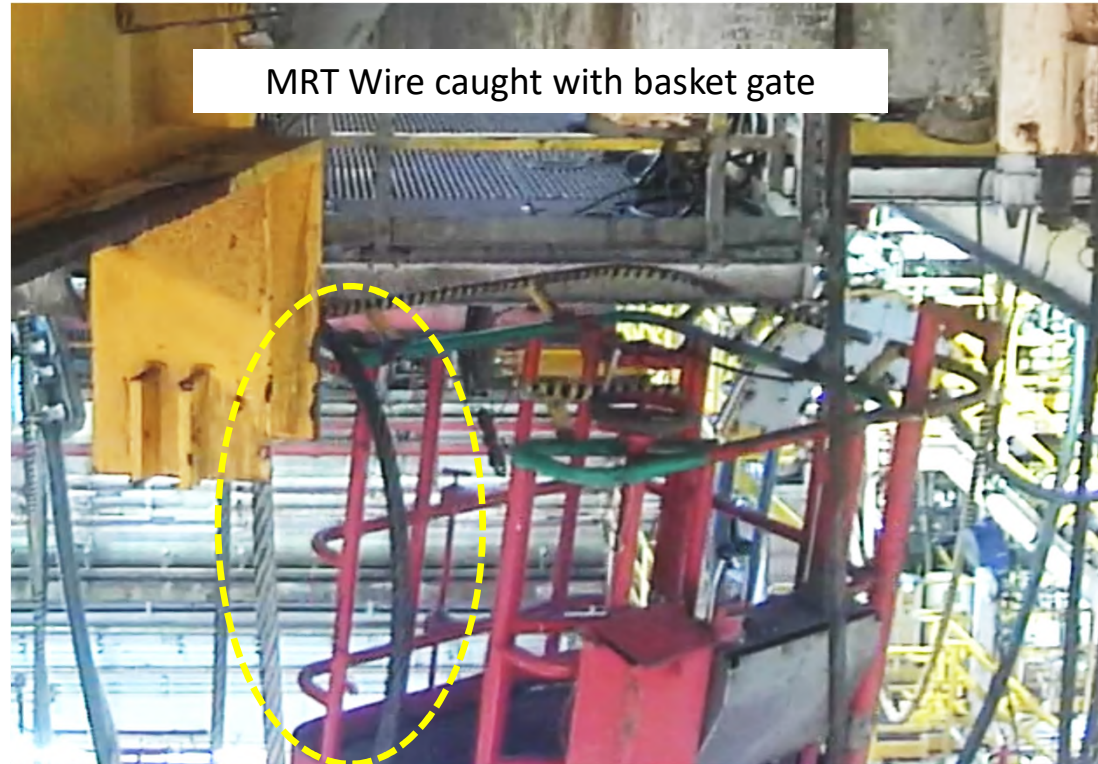
- Risk of positioning the basket close to the MRT wires was not assessed.
- Basket gate had been left open.
- Basket handrail had been modified.
- The hazard of the caught wire was not identified prior to repositioning the basket.
- Operators view was restricted.
- No spotter or banksman was assigned.
- Operator was a contract worker and not fully familiar with the operation of the basket.
- OJT did not include a demonstration or assessment of competency.
- No procedure or checklist exist for using the basket unmanned.
- Vulnerability of the basket axle design highlighted.

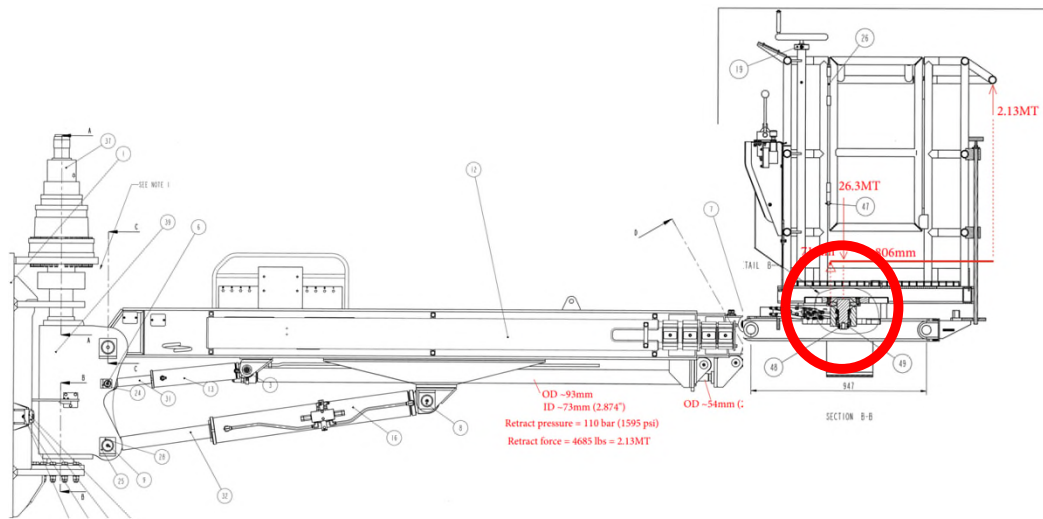
**Basket rotation axle  
vulnerable to overloading**
